Covered Waste Treatment Tanks Create First-of-Many Opportunities for Seasafe Walkways

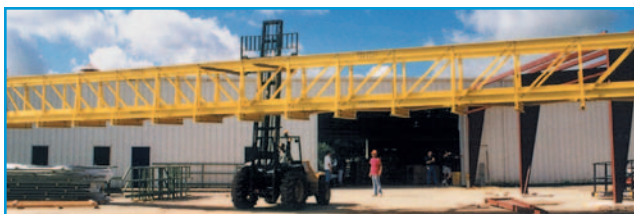
The entire structure is light enough to be positioned on the trailer by one forklift. Although light in weight, it has an 8:1 safety ratio.

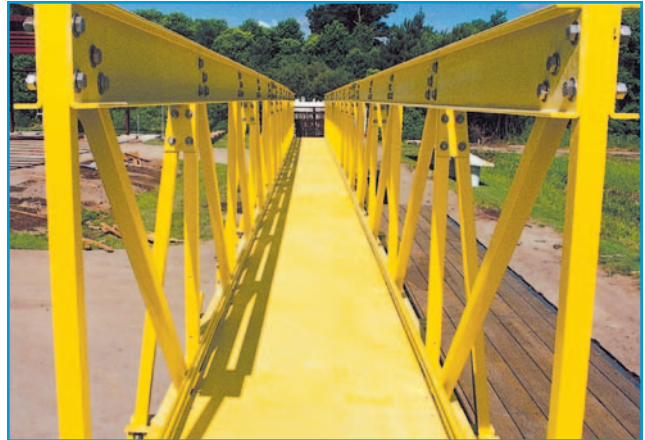
surface constructed with Seasafe's *Gatordeck* Gd-16010 1" thick pultruded grating with IFR resin incorporating 1/8" thick top and bottom cover plates. The truss is fiberglass *Gatorshape* structural shapes, all in yellow. The hardware is 3/4" stainless steel bolts and nuts.

The sedimentation tanks are 148 feet in diameter. Each walkway has a clear span of approximately 75 feet and is 5 feet wide. All have a walking
